EXPERIMENTAL RESULTS AND DISCUSSION

5.1 DATA GATHERED

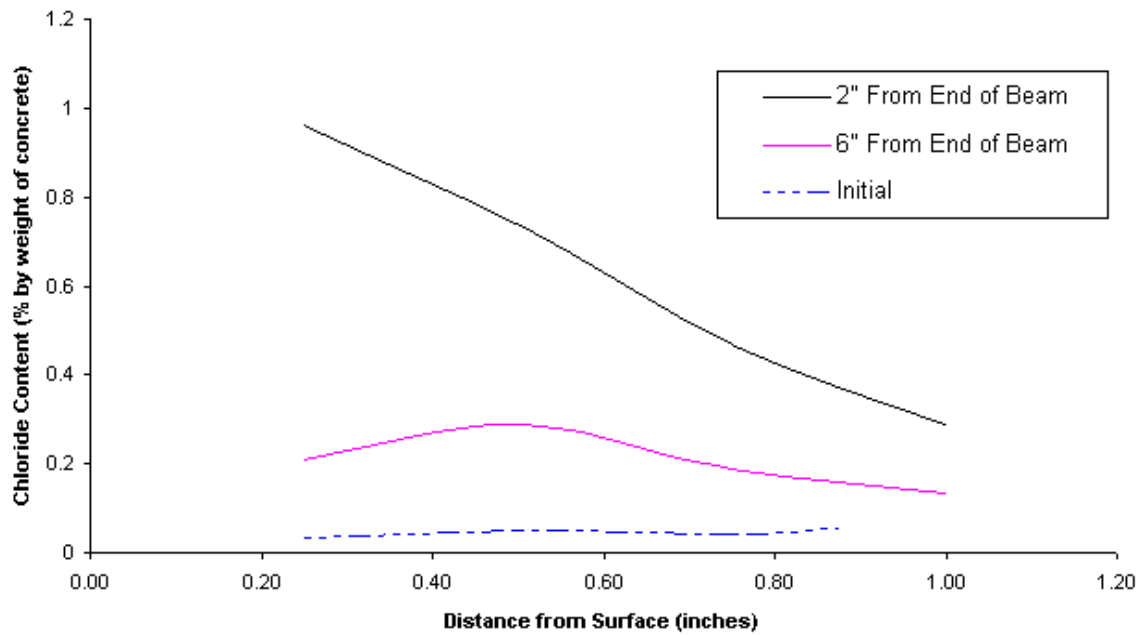
Figure 27. Comparison of Chloride Contents – Phase I

The measurements indicate high chloride concentrations near the surface, with the values decreasing with increasing distance from the surface. This is consistent with the behavior of chloride ions migrating into the concrete. Figure 27 illustrates the comparison of the collected chloride content data.

Research conducted by Lewis [26] suggests that the corrosion threshold value is 0.15% of acid soluble chloride by weight of cement. ACI Committee 222 [52] recommends the corrosion threshold value of 0.2% acid soluble chloride by mass of cement. Recently, other researchers have suggested a large variation in the corrosion threshold. In either case, the currently utilized corrosion threshold is exceeded at all depths measured at a distance of 2 inches from the end of the beam. At the location of 6 inches from the face of the beam, the corrosion threshold level is exceeded up to a depth of $\frac{1}{2}$ inch.

The highest chloride levels are observed in the beam-end with patch repairs. Acid-soluble chloride levels are on the order of 1.0% by weight of concrete is measured at depth of up to 1.0 inch. It appears that the interface between the old and new concretes may have allowed accelerated intrusion of chlorides deep into the patch and old concrete.

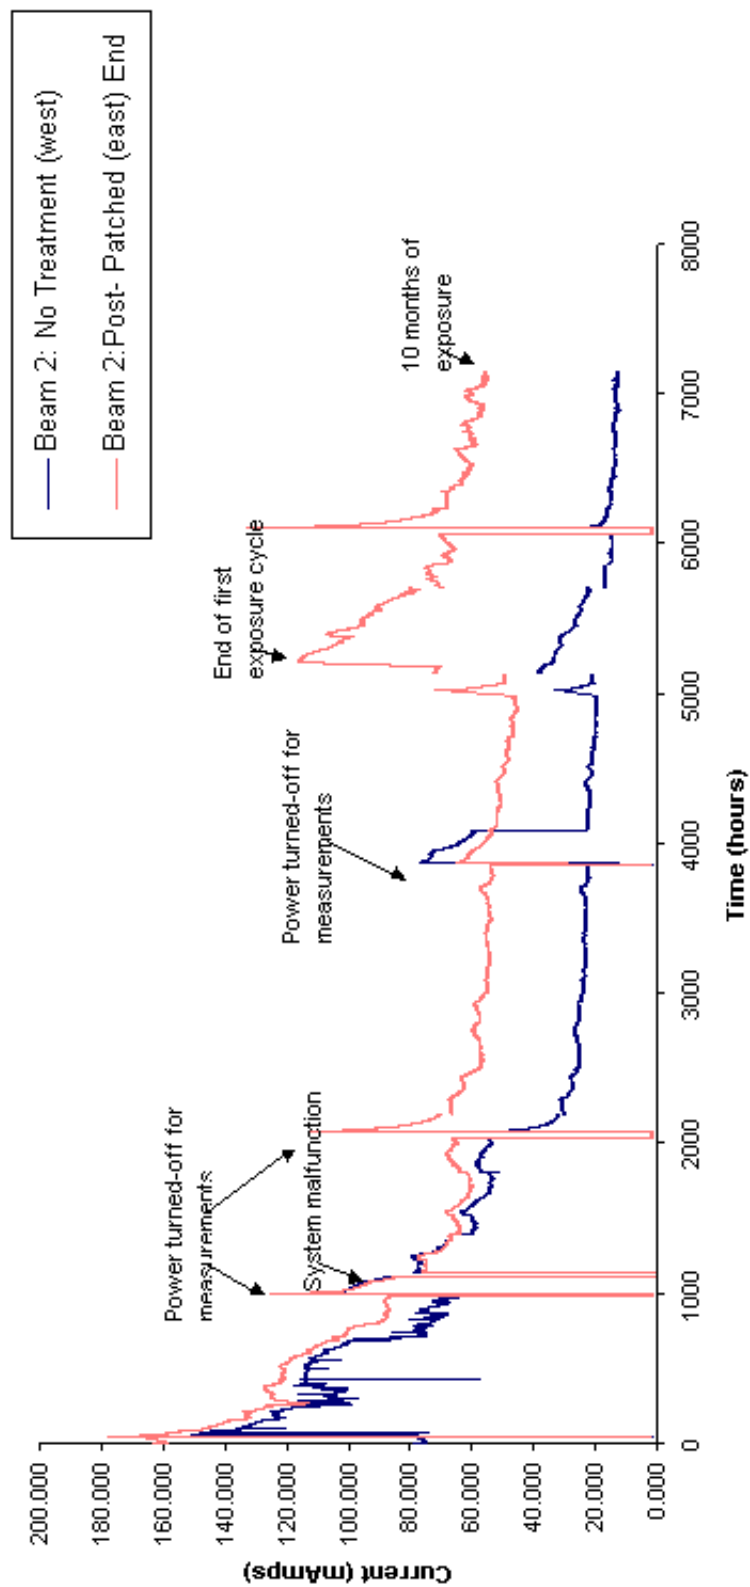
Figure 29. Corrosion Current vs. Time – Beam-Ends 2A (West) and 2B (East)

The corrosion vs. time curves for the two ends of beam 2 are relatively similar until about 2000 hours into the experiment. After which, the “no-treatment” or west end experiences a significant decrease in current. Since these ends were exposed to the same exposure condition and both were initially untreated, their curves should be approximately equal for the first 6 months of the study. Given that the untreated end diverges so significantly, it can be deduced that there may have been electrical connection problems occurring with this end. It was observed that at the end of the first phase of exposure, there was only one undamaged connection between the beam end and the applied voltage. Therefore, the difference observed between the curves for the ends of beam 2 is more than likely due to electrical connection

problems, and does not reflect that less corrosion is occurring in the untreated, west end compared to the untreated, east end.

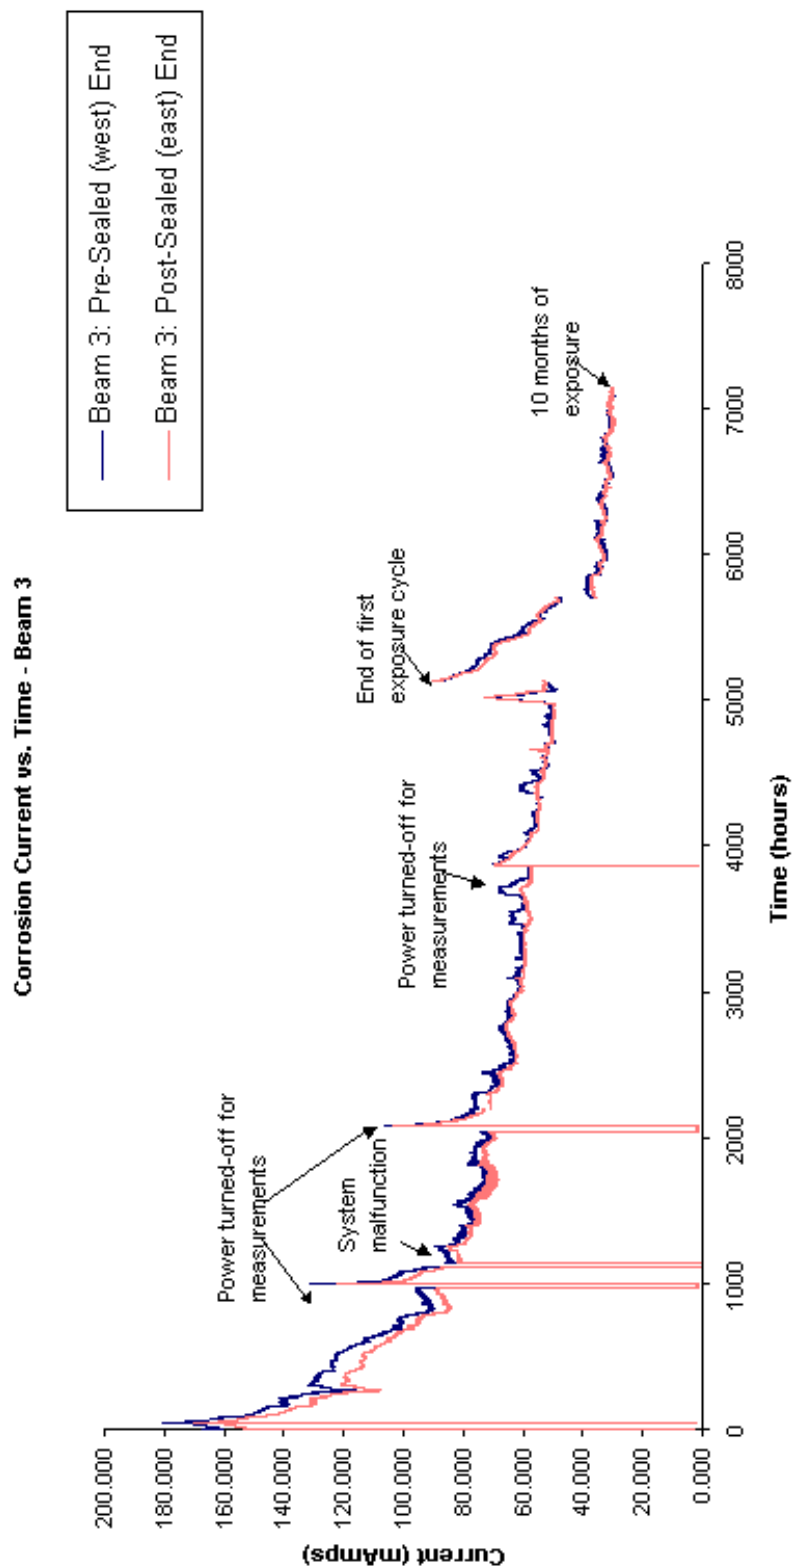
Figure 30. Corrosion Current vs. Time – Beam-Ends 3A (West) and 3B (East)

The corrosion current versus time curves for the two ends of beam 3 are generally similar for both the pre-sealed (west) end and the untreated, later sealed (east) end. This behavior is observed at the end of the first phase of the experiment and continues after 10 months of exposure. Since these curves are exhibiting similar behavior, it can be concluded that the pre-sealed end behaved the same as the initially untreated end. Therefore, this data seems to indicate that the penetrating sealer did not have a noticeable effect on preventing corrosion and the subsequent steel loss in the beam.

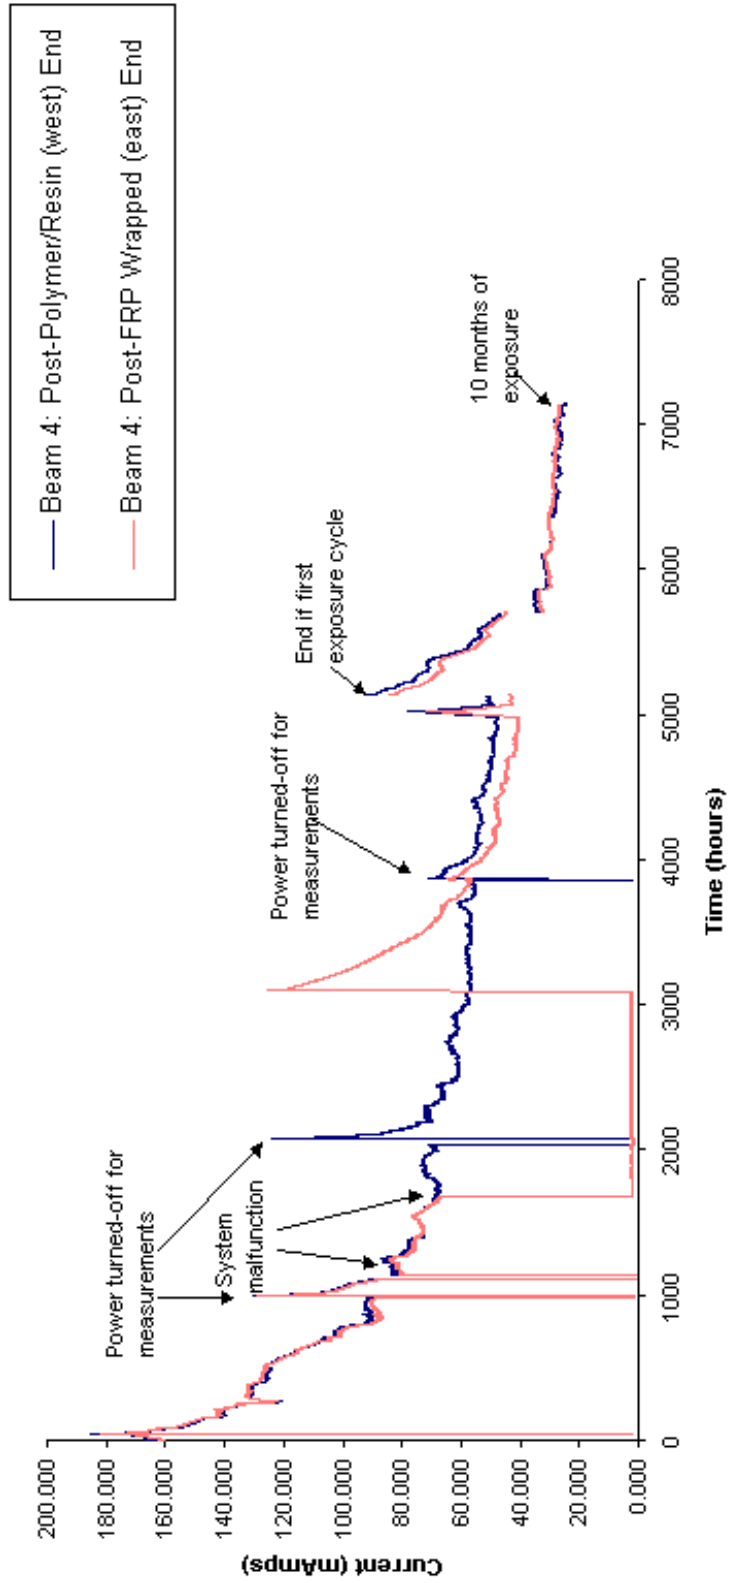
Figure 31. Corrosion Current vs. Time – Beam-Ends 4A (West) and 4B (East)

The corrosion current versus time curves for the two ends of beam 4 are nearly the same for both initially untreated ends. The exception is between approximately 1700 and 3000 hours, where the current drops to zero for the post-FRP wrapped (east) end. The drop in current was due to a loose connection between that end and the applied voltage. When the drop in current was observed, the connection was evaluated and remedied. After the readings stabilized once the connection was reestablished, the behavior of both curves returned to be nearly equal. Since both ends were initially untreated and subjected to the same exposure conditions, the graphs should display nearly the same behavior. For the 10 months of total collected data, the curves continue to be approximately equal after the polymer (resin) and FRP wrap was applied.

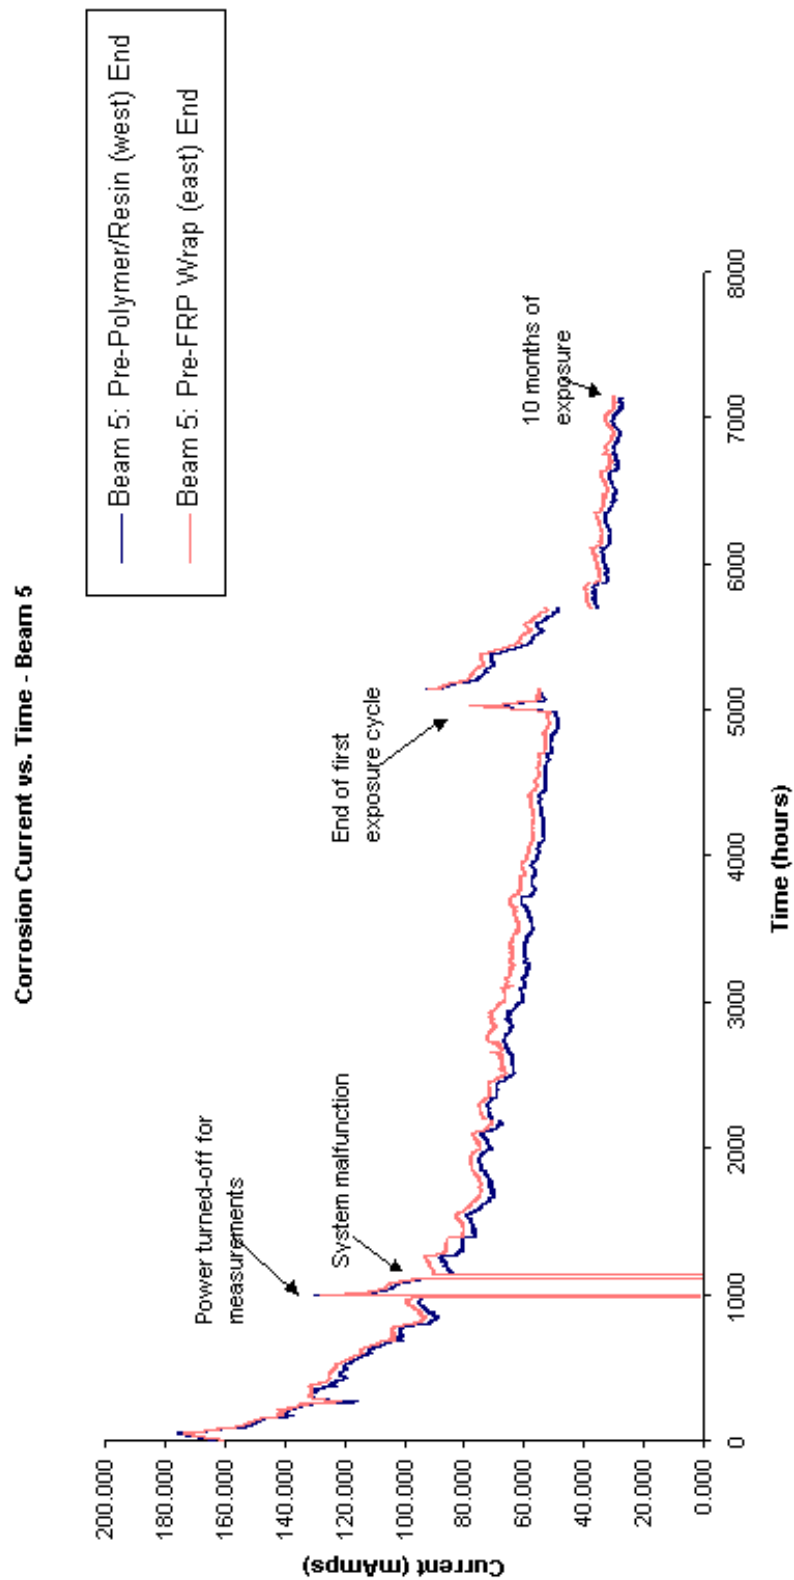
Figure 32. Corrosion Current vs. Time – Beam-Ends 5A (West) and 5B (East)

The corrosion current versus time curves for the two ends of beam 5 are nearly the same for the 10 months of collected data. The end pretreated with the polymer (resin) has a slightly less corrosion current in comparison to the end pretreated with FRP wrap (east). Form the

existing data collected, it can be concluded that both ends are experiencing similar corrosion damage, and therefore have similar effectiveness.

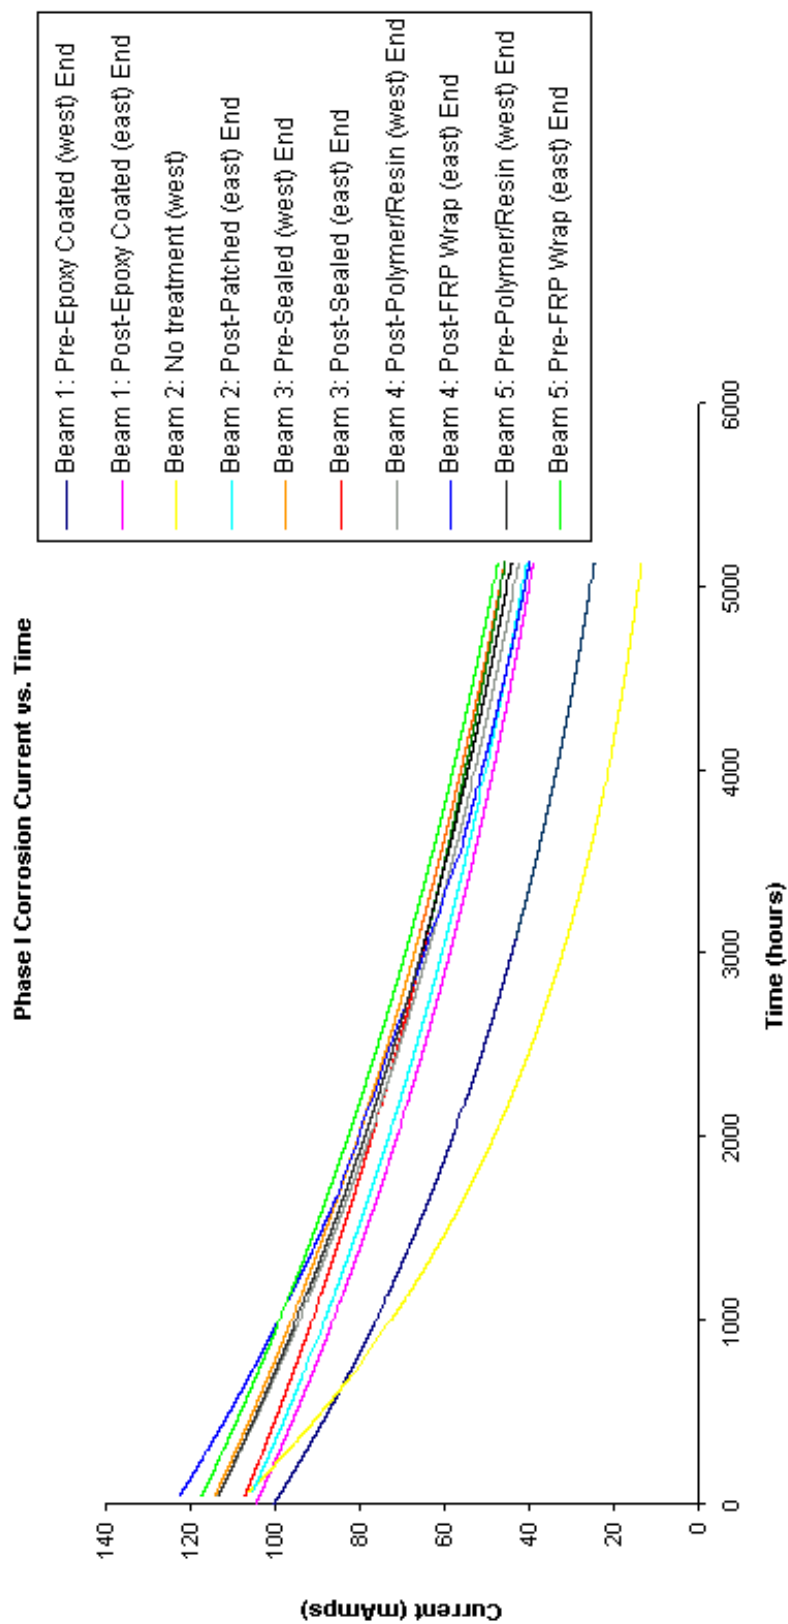
Figure 39. Best-Fit Curve: Corrosion Current vs. Time – All Beam Ends

Figure 39 illustrates the combination of corrosion current versus time for all the beam-ends. The “no treatment” end of beam 2 exhibits the lowest corrosion current over time. As explained earlier, this is likely due to electrical connection problems with this particular end, and is not representative of its true behavior in preventing corrosion. The next lowest curve is the end of beam 1 pretreated with a coating. The end that exhibits the largest corrosion current versus time is the end pretreated with the FRP wrap. However, all curves for each of the beam-ends are clustered closely together. Therefore, based on the 6-month exposure data, a conclusive assessment of the effectiveness of various treatments cannot be made.

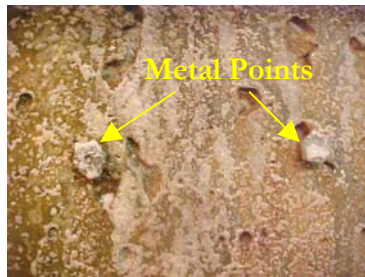
Figure 59. Measurement Points

data over the course of the experiment. There were also difficulties encountered obtaining consistent readings with the measurement device. The tip of the device was conical, and hence the measurements could vary depending on the angle the device was placed into the point. Since many of the metal points were located in the path of the salt water, overtime they softened, with many corroding (see Figure 59).

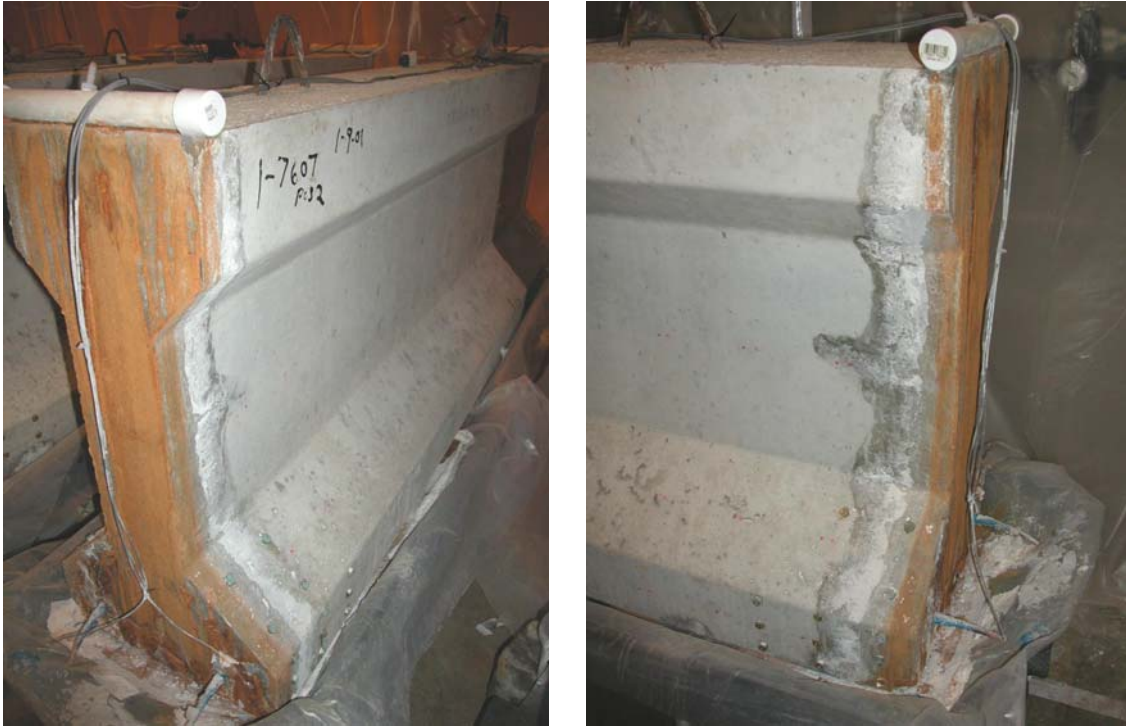
Figure 63. Beam End 1B: Northeast Face (left), Southeast Face (right) (after 6 months)

At the completion of the first exposure cycle the beam-ends had heavy salt residue along the front faces and on some portions of the bottom flanges. Rust stains were also evident along the path of the salt water. No major spalling or cracking was observed. Some flaking of concrete was observed at the corners of the beam. In addition, corrosion products were observed on the exposed tendon ends, and were found to increase in amount over the course of the exposure.

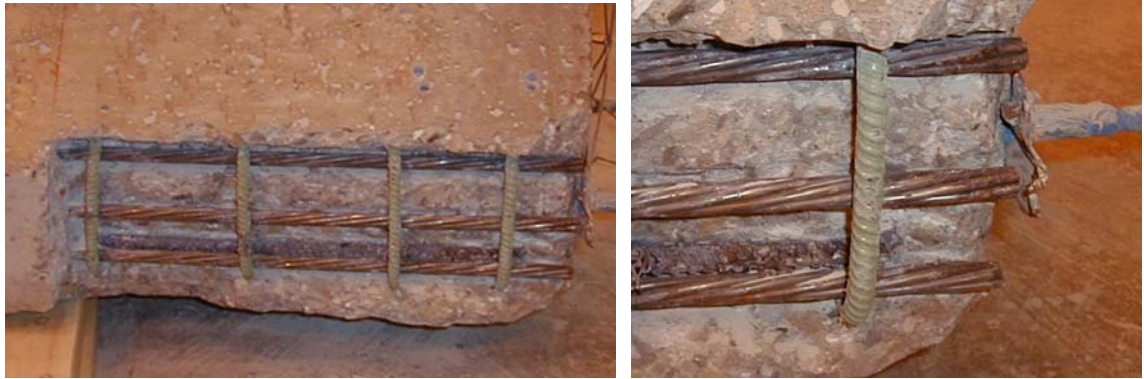
Figure 71. Beam Section Removed for Patch Repair

After 6 months of exposure, both ends were cleaned to remove salt residue and rust products from the surface of the beam. Since 6 months of exposure did not result in the spalling of concrete, an 18-inch long concrete region of the east end was removed with a chipping hammer for installation of the patch repair (see Figure 71).

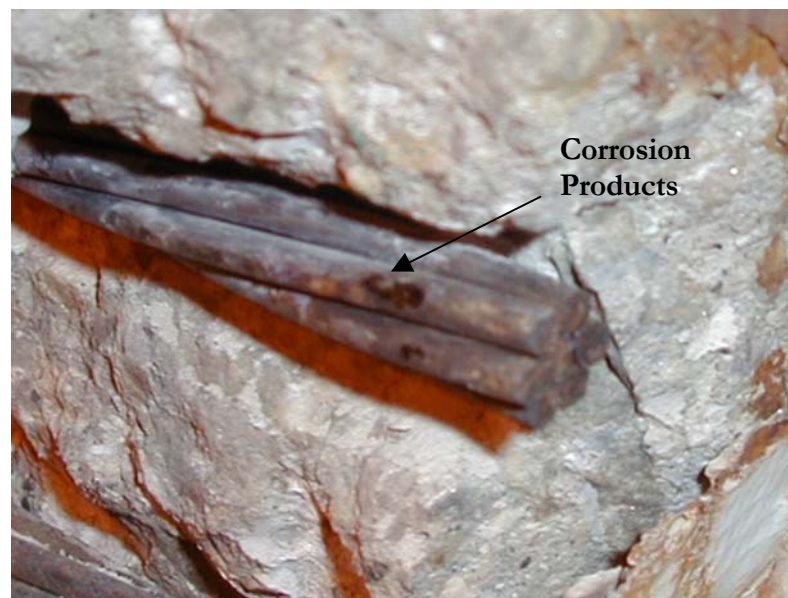
Figure 72. Close-up View of Tendon from Dissected Beam End

Figure 72 shows a close-up view of one of the strands. Corrosion products were observed mainly at the end regions of the strands. The build-up of corrosion products was seen to decrease as the distance from the edge of the end increased. The amount of corrosion was less than the researchers had expected. It was determined to change the configuration of the salt-water exposure to facilitate greater exposure on the sides of the beam to salt water.

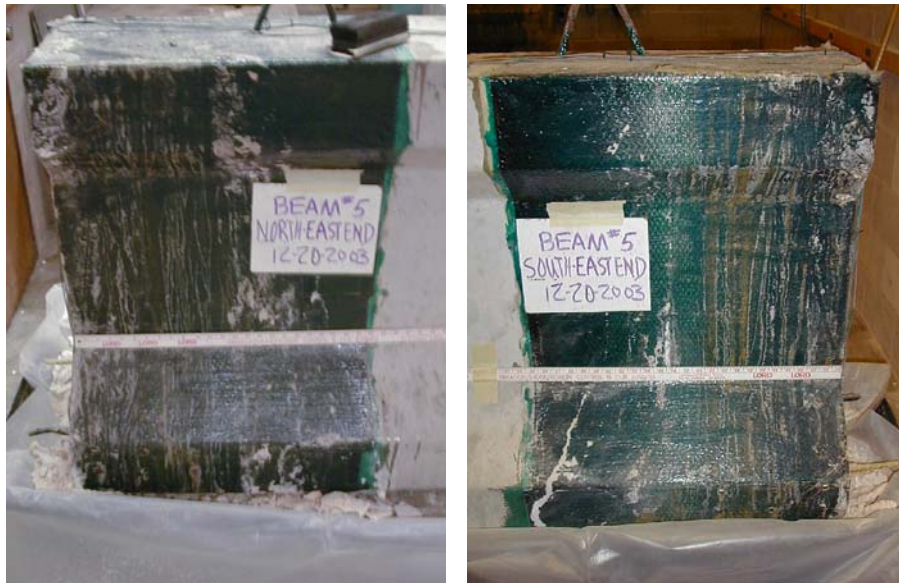
Figure 93. Beam End 4B: Northeast (untreated, post-FRP) (left), Southeast (right) (18 months)

No spalling or major cracking was observed on either of the beam-ends at the end of 18 months of exposure.

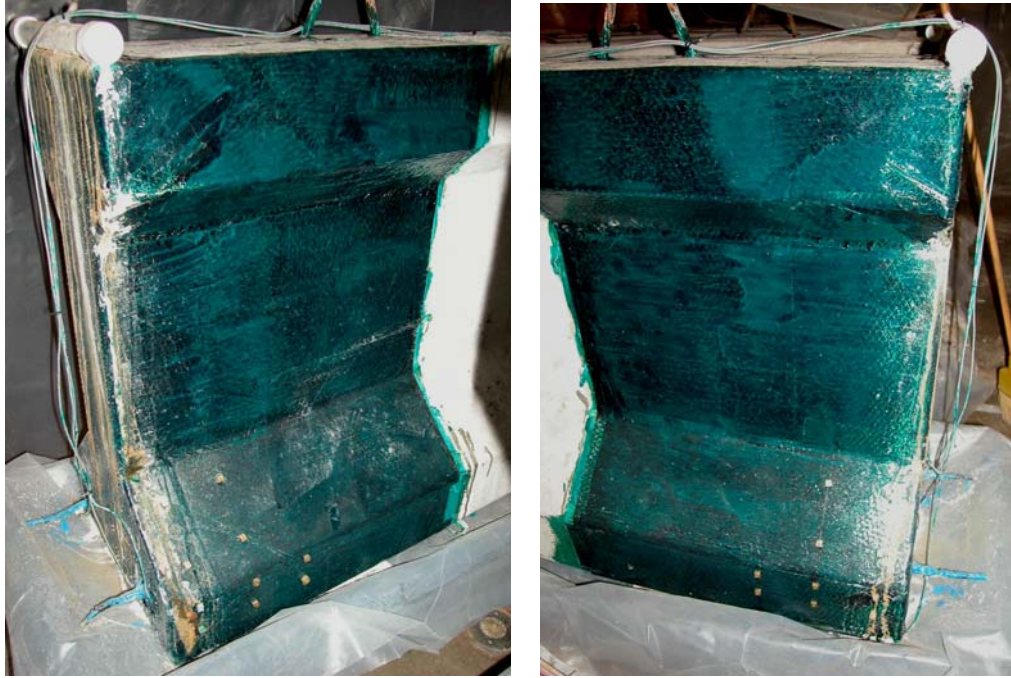
Figure 97. Beam End 5B: Northeast Face (left), Southeast Face (right)(After 6 months)

No major spalling or cracking was observed at the end of 6 months of exposure.

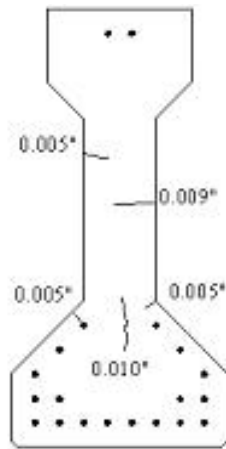
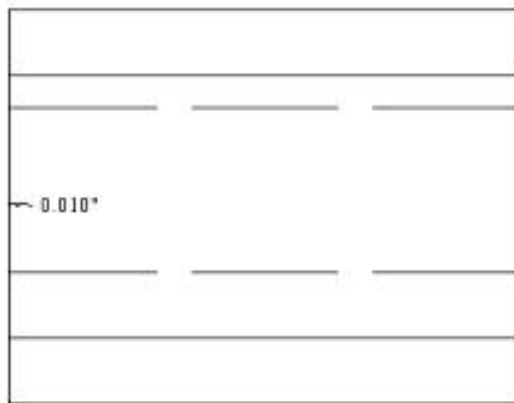
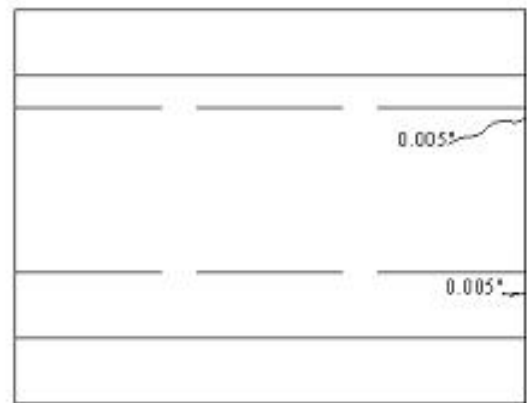
Figure 103. Beam End 1A: West End (top), Southwest (left), Northwest (right) (18 months)

Figures 103 and 104 show crack maps for the 1A and 1B ends at the conclusion of testing (18 month). There is only a slight progression of cracking on the northwest side of 1A from 6 months of exposure to 18 months. However, the 1B end did develop extensive new cracks at the end of the 18-month exposure period. This is expected as 1B was subjected to 6 months of unprotected exposure to saltwater before application of epoxy coating.

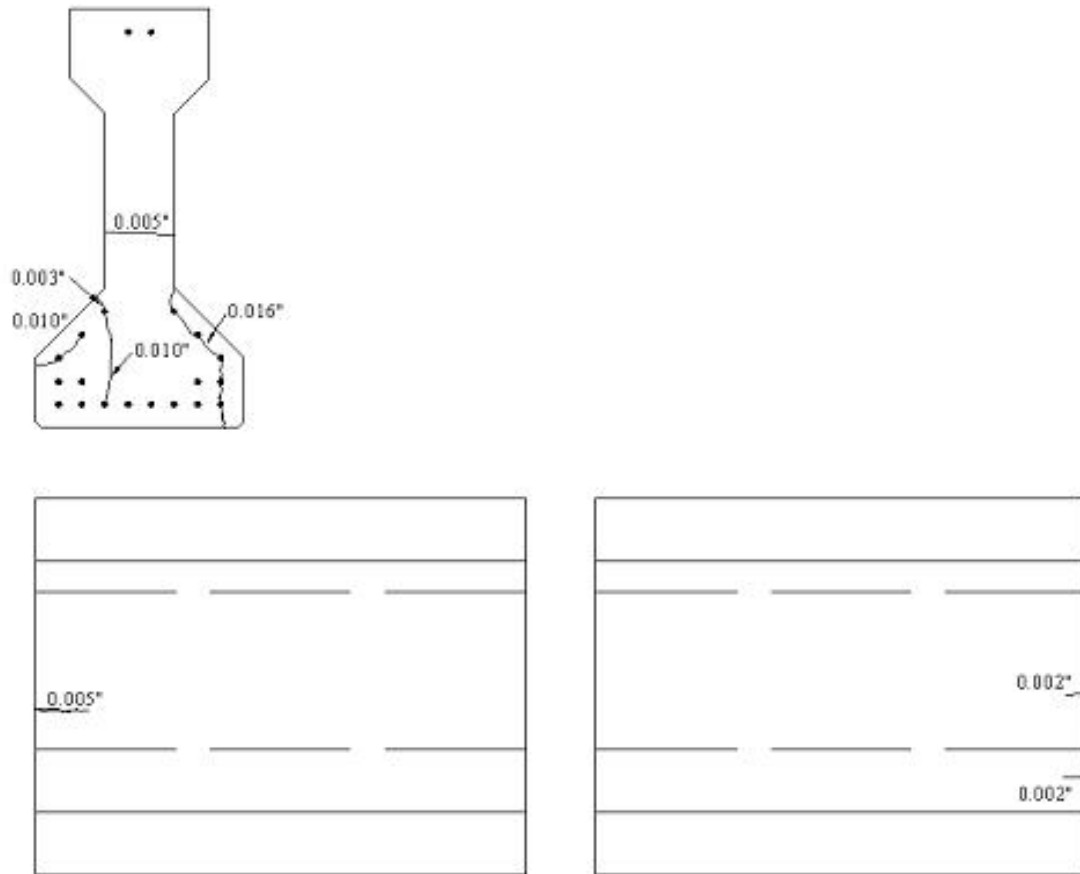
Figure 115. Beam End 4A: West (top), Southwest (left), Northwest (right) (18 months)

Figures 115 and 116 show crack maps after 18 months of exposure for the 4A and 4B beam ends, respectively. Additional cracking developed at the end face of 4A from 6 months to 18 months.
